**CLEAR LAKE DAM
JEFFERSON COUNTY, MISSOURI
MO. 30437**

**PHASE I INSPECTION REPORT
NATIONAL DAM SAFETY PROGRAM**

PREPARED BY: U. S. ARMY ENGINEER DISTRICT, ST. LOUIS

JULY 1981

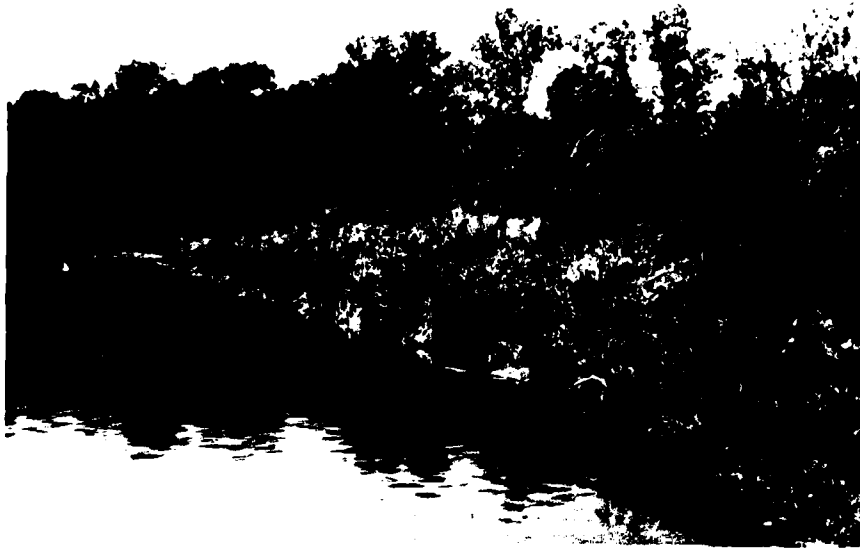
The upstream slope of the dam is not protected by riprap; consequently, some damage due to wave action was observed on the slope. Near vertical scarps up to two feet high were observed in some areas above the normal water surface level. A small bench was observed just below the normal water surface level, which also appeared to have been formed due to wave action. A surficial layer of rock was observed on the slope, but it provided little or no protection. The portion of the slope above the normal water surface is adequately protected against surface runoff by an unmaintained vegetative cover ranging from tall grass to small bushes (see Photo 1). No trees were observed on the upstream slope; however, several small saplings were growing on the slope. The steepness of the upstream slope above the normal water surface level did not appear to be indicative of the slope angle for the remaining portion of the slope. Nevertheless, the combination of the steepness of the slope

Photo 1 - View of the upstream slope from the right abutment.

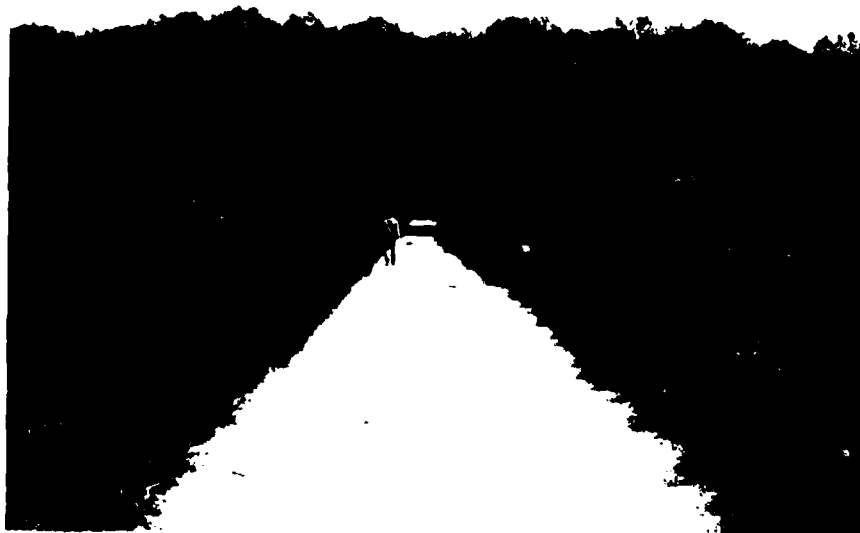
The top of dam supports a gravel access road used by local residents to gain access to their homes (see Photo 2). Outside of the access road, the top of dam has a vegetative covering. The gravel surfacing and vegetative covering appear to provide adequate erosion protection against surface runoff, for no erosion was evident. No damage due to vehicular traffic across the dam was seen; however, in a few areas, patches of asphalt, which appeared to have been used to fill in potholes, were observed. No depressions or cracks indicating a settlement of the embankment were apparent. The variation in elevation across the top of dam did not appear to be due to an instability of the embankment. No significant deviation in the horizontal alignment was apparent. According to Mr. Shy, the dam has never been overtopped and no evidence indicating the contrary was observed.

Photo 2 - View of the top of dam from the left end of the dam.

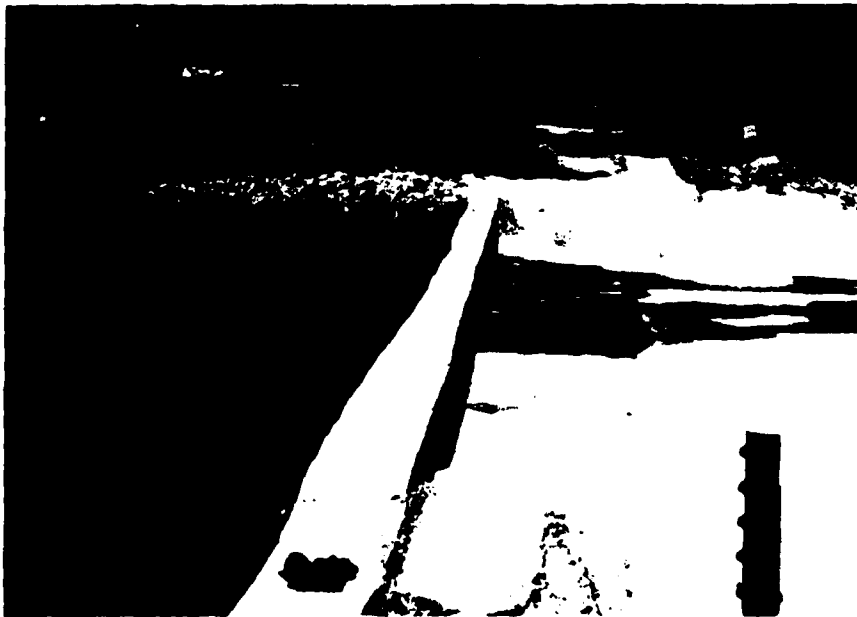
An addition was made to the concrete weir, one or two years ago, increasing the thickness from eight inches to the existing 1.8 to 2.3 feet thickness. As described in Section 1.2g, the purpose of the addition was to extend the cutoff wall further below the spillway slab in order to stop seepage under the slab. The new cutoff wall did not stop the seepage, but did reduce the flow, according to Mr. Sells. Water was observed flowing between the spillway slab/natural ground interface at the outfall of the spillway channel. The flow rate was estimated to be less than five gallons per minute. The discharge was clear and no undermining along the length of the spillway slab due to the seepage was evident. The placement of the addition was done in an unprofessional manner evidenced by the variable thickness of the resultant structure (see Photo 6). Although the newer concrete appeared undamaged and sound, water was flowing through cracks in the weir near the channel invert at the centerline of the spillway (see Photo 6).

1. The leakage through the spillway system will only hasten the demise of the spillway channel. It appears that flow is following the spillway slab/natural ground interface and exiting at the top of the vertical face of the undermined area of the spillway outfall, which could be contributing to the erosion there.

Photo 6 - View of the weir at the spillway control section and seepage into the spillway channel.

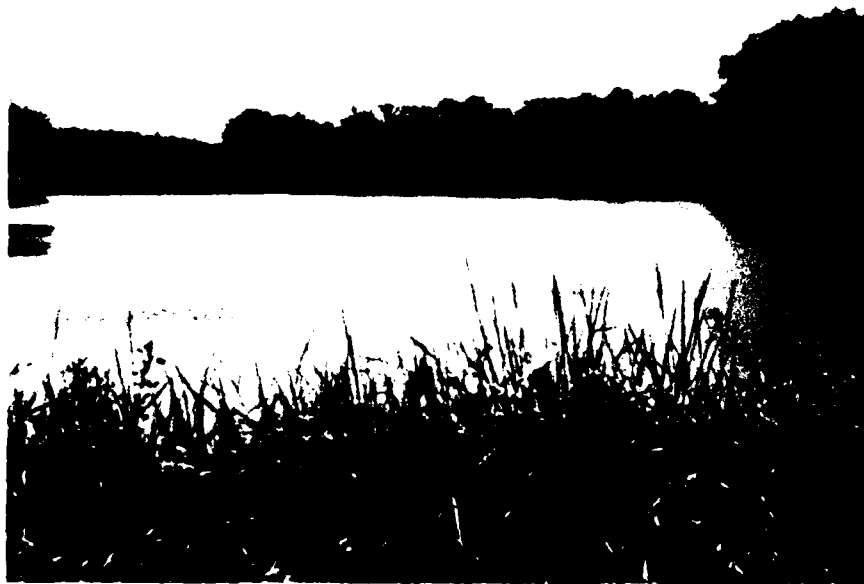
The rim appeared to be stable with no erosional or stability problems observed (see Photo 13). The land around the reservoir slopes gently to moderately upward from the reservoir rim and is mostly wooded with grass-covered slopes. Several houses are built around the reservoir rim. No evidence of excessive siltation was observed in the reservoir on the day of the inspection.

Photo 13 - View of the reservoir and rim. Note Sunrise Lake Dam in the background.
